CENTRAL TEXAS
Regional Mobility Authority

183A Turnpike
2011 Annual Inspection
Detailed Inspection Report

**183A Turnpike
2011 Annual Inspection
Detailed Inspection Report**

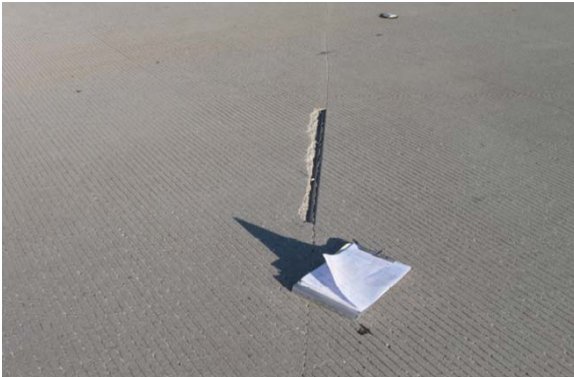
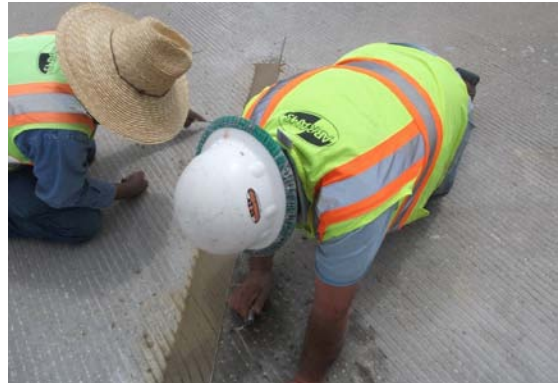
- Erosion around columns and deck surface joint spalling was identified.
- Erosion should not impact the bridge structure because all bents are sufficiently founded in limestone.
- The distressed bridge deck joint was repaired by Hill Country Constructors on April 27, 2010. Following is a photo of the bridge deck joint repair work that was performed by the Developer:

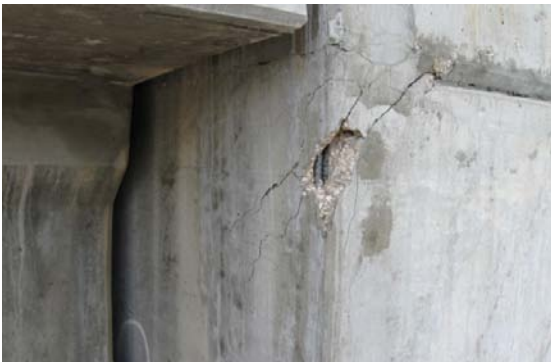
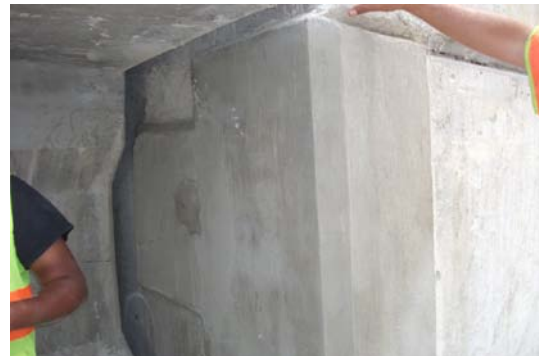
Bridge Number: 14-246-T001-83-011

- Spalling at the abutment / wing wall convergence was identified. Hill Country Constructors repaired concrete in April 2010 by chipping away distressed material and applying a cement bonding agent. The following is a photo of the repaired area:

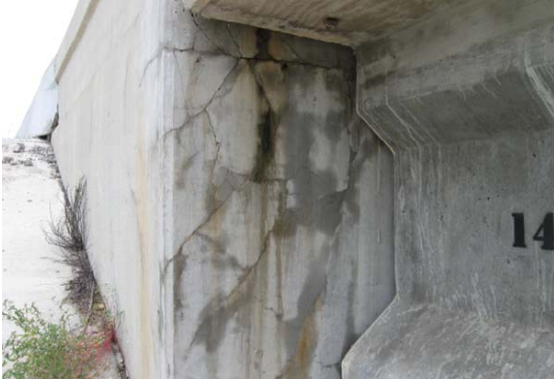
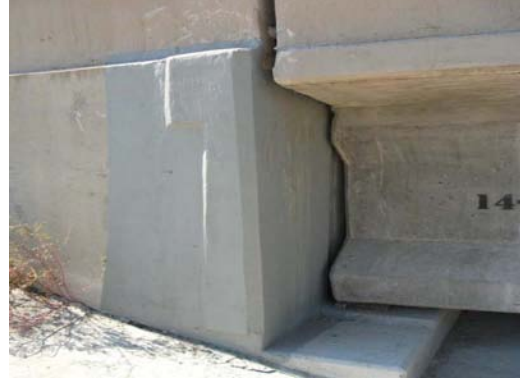
Bridge Number: 14-246-T001-83-012

- Spalling at the abutment / wing wall convergence was identified. Hill Country Constructors repaired concrete in April 2010 by hydroblasting concrete and applying a cement bonding agent. The following are photos of corrected deficiencies.
