**CENTRAL TEXAS**  
**Regional Mobility Authority**

**2013 Annual Report of Conditions**  
**183A Turnpike**

**HNTB**

**Re: Revised Final 2013 Annual Report of Conditions – 183A Turnpike**

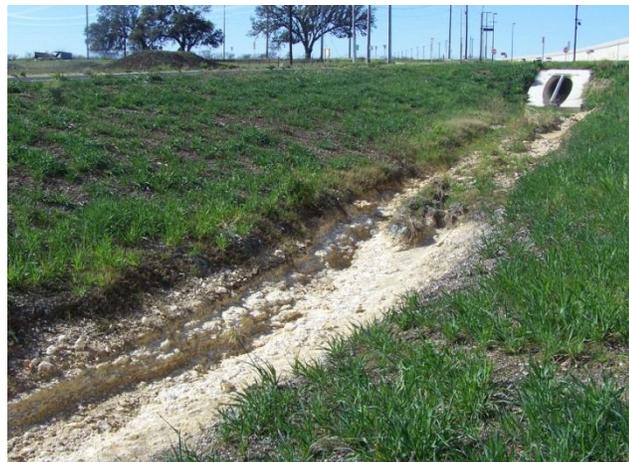
Instances of erosion were also observed during the 2013 inspection throughout the 183A Phase II Extension Project limits. These instances appear to have been the result of lack of vegetation establishment. The contractor has since completed re-seeding and installing erosion protection mats to correct the majority of these areas and prevent further erosion. The remaining areas with erosion issues should continue to be monitored.

Observed Channel Erosion

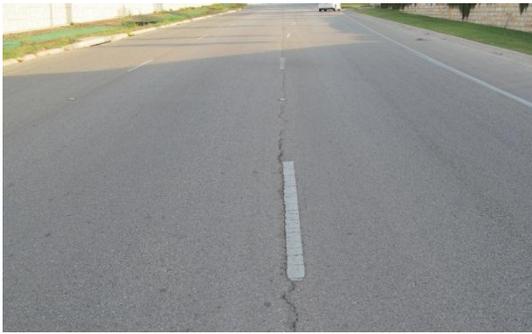
**Pavement Condition, Striping and Markings**— During the 2013 Inspection period, the primary deficiency identified was longitudinal and fatigue cracking along the asphalt paved frontage roads between FM 1431 north to the intersection with US 183. The issues witnessed are seemingly the result of poor workmanship by the Developer of the 183A Phase I construction. As a result, these areas will be corrected under the Warranty Provisions identified in the CDA. Below are some examples of areas from the inspection.

Observed Longitudinal Cracking

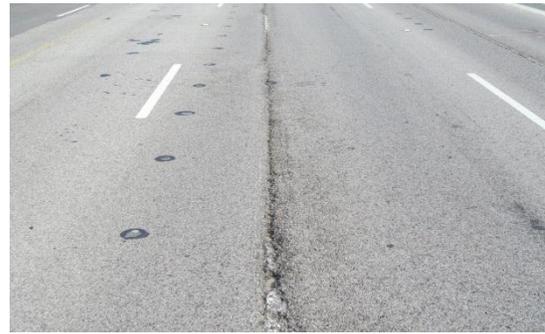
Observed Longitudinal Cracking

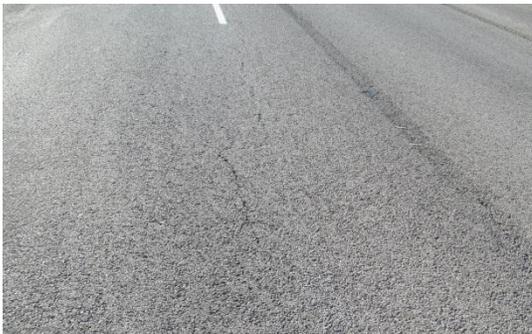
Observed Fatigue Cracking

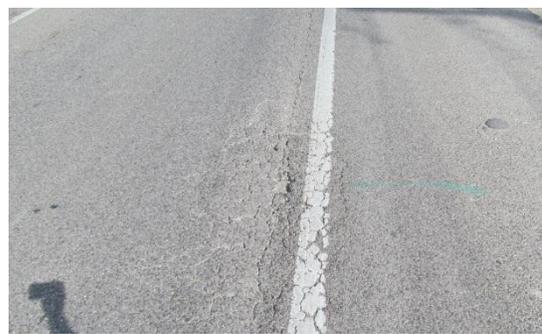
Observed Fatigue Cracking

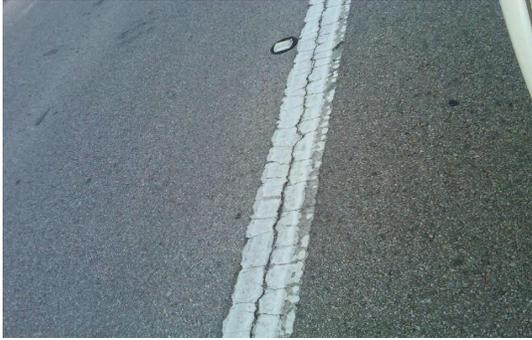
The striping along the northbound and southbound frontage road is in fair condition. The pavement markings are visible but are experiencing fading and cracking along a majority of both the northbound and southbound frontage roads. The highest concentration of fading occurs at the approaches to each intersection with cracking occurring throughout.

Observed Pavement Marking Cracking

The markings along the mainlanes are in good condition with some fading but isolated primarily at the ramp gores. As a maintenance measure, the striping should be replaced in these areas. The striping on the mainlanes will be addressed under the Performance Based Maintenance Contract ILA with TxDOT where the striping on the frontage roads between FM 1431 and US 183 will be addressed under the warranty corrective actions per the requirements of the 183A Phase I CDA.

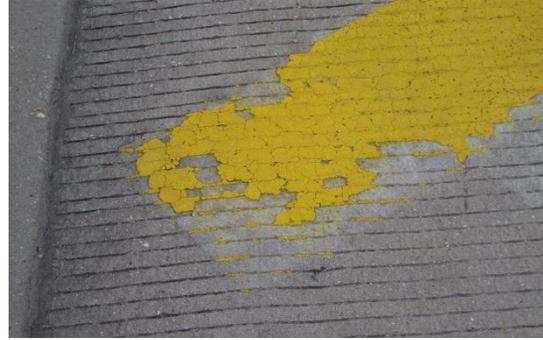
Observed Pavement Marking Fading
