CENTRAL TEXAS REGIONAL
MOBILITY AUTHORITY

ANNUAL REPORT OF CONDITIONS

CENTRAL TEXAS REGIONAL MOBILITY AUTHORITY SYSTEM

Subject: 2025 Annual Report of Conditions - 183A Turnpike, 290E, SH 71 Express, SH 45 Southwest, 183 South, 183A Phase III Project, 183 North Mobility Project

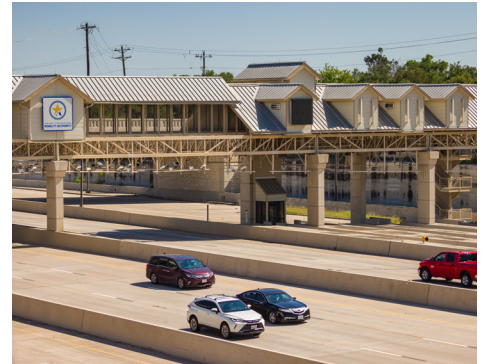
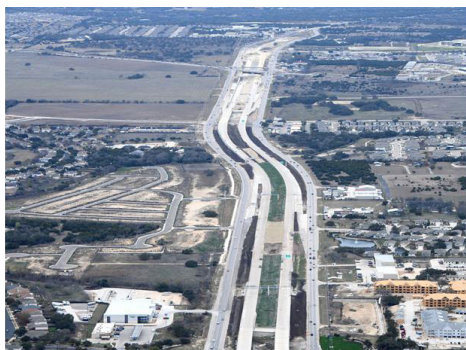
1.3.1. 183A TURNPIKE

The Mobility Authority constructed, operates and maintains the 183A Turnpike, a tolled facility stretching 11.6 miles from RM 620 to Hero Way in Williamson County. The corridor is a critical link in the highway network serving an area experiencing tremendous development and economic growth. The Project included phased construction with Phase I opening in 2007, Phase II opening in 2012, and intersection improvements opening in 2015 effectively reducing congestion, enhancing mobility, and providing safer travel and better access to developments along the corridor. Additionally, the project includes 6.9 miles of shared use path and connections to regional trails.

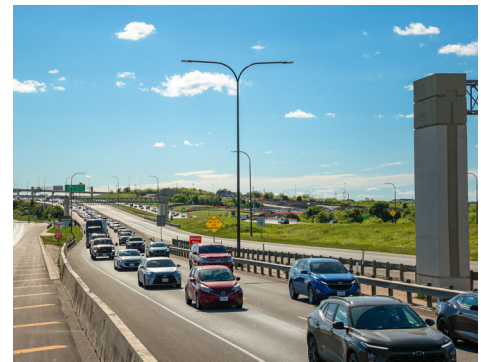
1.3.3. 290E

The Mobility Authority constructed, operates, and maintains the 290E, a toll road along US 290 from US 183 to just east of Parmer Lane with 7.3 miles of improvements. It includes three tolled mainlanes and three non-tolled general-purpose lanes in each direction, direct connectors (DCs) to US 183 and SH 130, and a 6.3-mile shared use path along the entire corridor. The corridor is a significant link to important roadways in the region including US 183, IH-35 and SH 130, and, effectively reduced congestion on US 290 and provides reliable travel times for tolled and non-tolled travel.

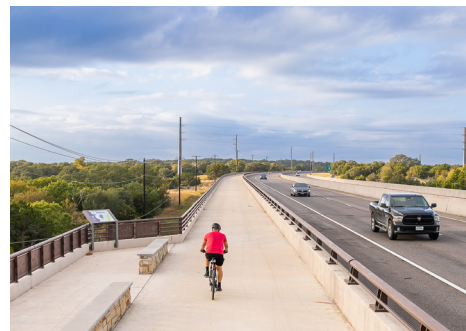
1.3.5. SH 45 SOUTHWEST

The Mobility Authority constructed, operates and maintains SH 45 Southwest, a tolled facility stretching from State Loop 1 (MoPac) to FM 1626 in southern Travis and northern Hays counties with 5.2 miles of improvements. The corridor, which opened to traffic in 2019, includes two tolled lanes in each direction and a 4.9-mile shared use path. The facility was built without frontage roads to limit impacts to the surrounding environment. The road offers drivers an alternative to congested neighborhood streets like Menchaca Road, Slaughter Lane and Brodie Lane.

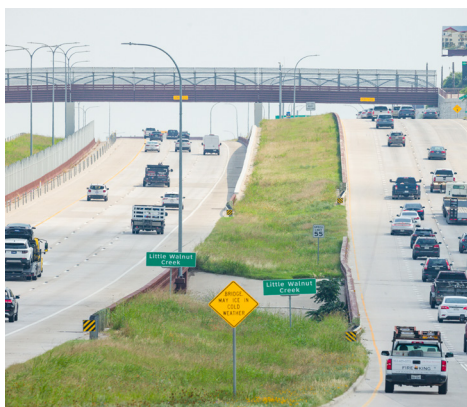
1.3.6. 183 SOUTH

The Mobility Authority constructed, operates, and maintains 183 South, an 8.3-mile-long toll road along US 183, spanning from US 290 to SH 71. The facility upgraded the previous four-lane US 183 to include three tolled mainlanes and three non-tolled general-purpose lanes in each direction – tripling the roadway’s previous capacity and constructed multimodal connections along the entire corridor offering greater mobility for all users of the corridor. Aesthetic enhancements are a major facility component and are visible in the unique design of the bridges, walls, and other features. The roadway makes it possible for drivers to travel from Austin-Bergstrom International Airport through Leander without stopping and provides a north-south alternative to I-35.

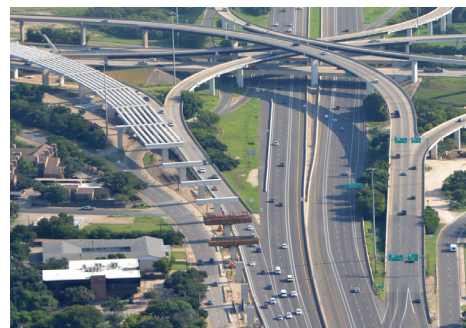
1.3.7. 183 NORTH MOBILITY PROJECT

The 183 North Mobility Project is currently constructing improvements along a 9-mile stretch of US 183 between SH 45 North/ RM 620 and MoPac. Improvements include two express lanes in each direction, the addition of a fourth general-purpose lane in each direction, and express lane DCs to and from southbound (SB) MoPac. The project also includes operational improvements for the transition to MoPac, new shared use path connections, new sidewalks, and cross-street connections for bicycles/pedestrians. Construction began in early 2022 and the project is expected to open to traffic in 2026.
