CENTRAL TEXAS REGIONAL
MOBILITY AUTHORITY

ANNUAL REPORT OF CONDITIONS

CENTRAL TEXAS REGIONAL MOBILITY AUTHORITY SYSTEM

Subject: 2026 Annual Report of Conditions - 183A Turnpike, 290E, SH 71 Express, SH 45 Southwest, 183 South, 183A Phase III Project, 183 North Mobility Project

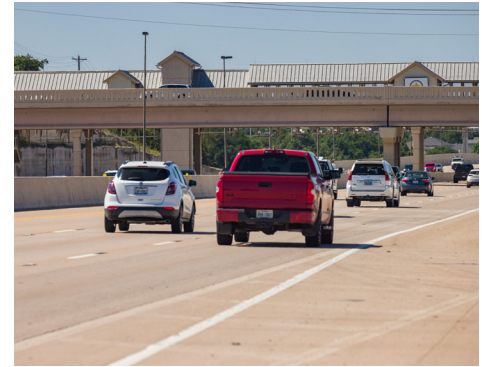
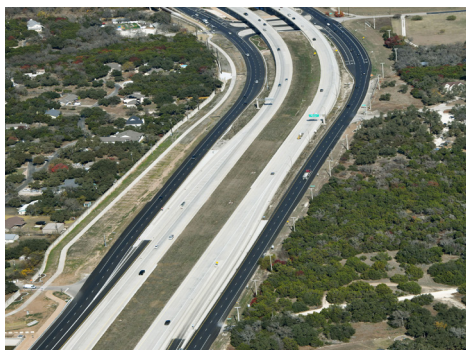
1.3.1. 183A TURNPIKE

The Mobility Authority constructed, operates and maintains the 183A Turnpike, a tolled facility stretching 11.6 miles from RM 620 to Hero Way in Williamson County. The corridor is a critical link in the highway network serving an area experiencing tremendous development and economic growth. The Project included phased construction with Phase I opening in 2007, Phase II opening in 2012, and intersection improvements opening in 2015 effectively reducing congestion, enhancing mobility, and providing safer travel and better access to developments along the corridor. Additionally, the project includes 6.9 miles of shared use path and connections to regional trails.

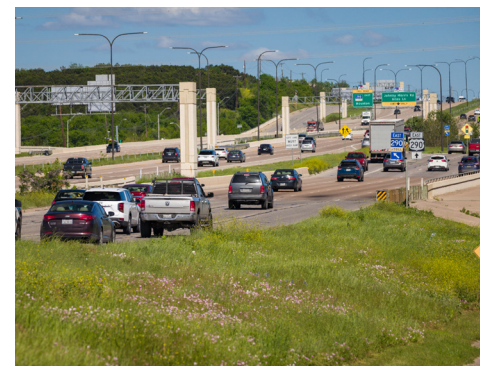
1.3.3. 290E

The Mobility Authority constructed, operates, and maintains the 290E, a toll road along US 290 from US 183 to just east of Parmer Lane with 7.3 miles of improvements. It includes three tolled mainlanes and three non-tolled general-purpose lanes in each direction, direct connectors (DCs) to US 183 and SH 130, and a 6.3-mile shared use path along the entire corridor. The corridor is a significant link to important roadways in the region including US 183, IH-35 and SH 130, effectively reduced congestion on US 290, and provides reliable travel times for tolled and non-tolled travel.

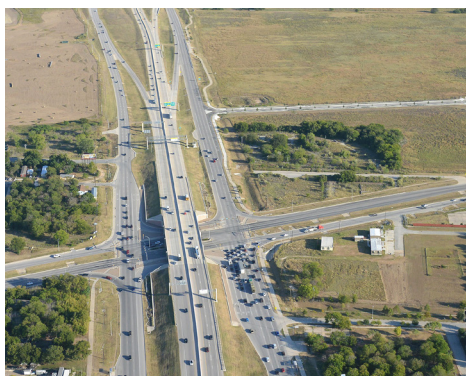
1.3.4. SH 71 EXPRESS

The Mobility Authority operates and maintains SH 71 Express, a 4-mile toll lane in each direction along SH 71 between Presidential Boulevard and east of SH 130 in Travis County. In addition to the tolled lane opened in 2017, the project added 5.6 miles of shared use path connections on both sides of the roadway, improved existing non-tolled lanes, constructed bridges over FM 973 and SH 130 to facilitate through-traffic movement, and ramps connecting SH 71 to SH 130 offering greater connectivity options to drivers. The facility enhances traffic flow, mobility, and driver and pedestrian safety along SH 71, a key east-west corridor connecting to the Austin-Bergstrom International Airport, the city of Bastrop, and points beyond.

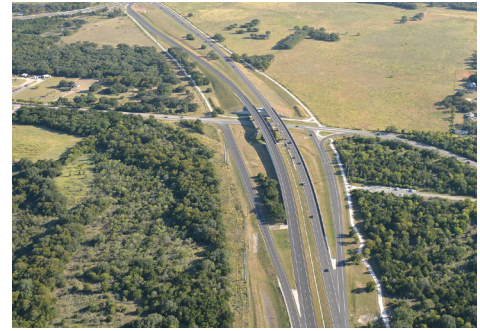
1.3.5. SH 45 SOUTHWEST

The Mobility Authority constructed, operates and maintains SH 45 Southwest, a tolled facility stretching from State Loop 1 (MoPac) to FM 1626 in southern Travis and northern Hays counties with 5.2 miles of improvements. The corridor, which opened to traffic in 2019, includes two tolled lanes in each direction and a 4.9-mile shared use path. The facility was built without frontage roads to limit impacts to the surrounding environment. The road offers drivers an alternative to congested neighborhood streets like Menchaca Road, Slaughter Lane and Brodie Lane.

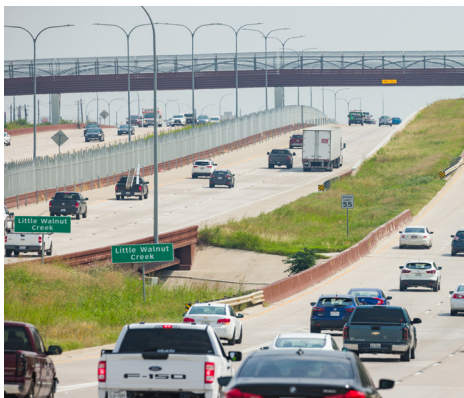
1.3.6. 183 SOUTH

The Mobility Authority constructed, operates, and maintains 183 South, an 8.3-mile-long toll road along US 183, spanning from US 290 to SH 71. The facility upgraded the previous four-lane US 183 to include three tolled mainlanes and three non-tolled general-purpose lanes in each direction – tripling the roadway’s previous capacity and constructed multimodal connections along the entire corridor offering greater mobility for all users of the corridor. Aesthetic enhancements are a major facility component and are visible in the unique design of the bridges, walls, and other features. The roadway makes it possible for drivers to travel from Austin-Bergstrom International Airport through Leander without stopping and provides a north-south alternative to I-35.

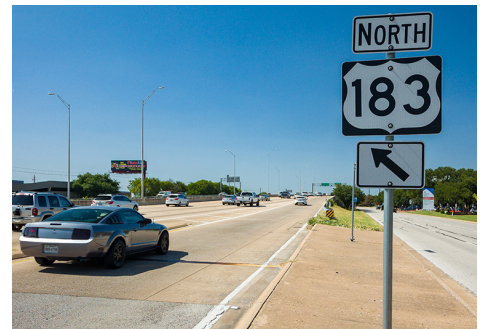
1.3.7. 183 NORTH MOBILITY PROJECT

The 183 North Mobility Project is currently constructing 12 miles of improvement on US 183 between SH 45 North/RM 620 and MoPac. Improvements include two express lanes in each direction, the addition of a fourth general-purpose lane in each direction, and express lane DCs to and from southbound MoPac. The project also includes operational improvements for the transition to MoPac, new shared use path connections, new sidewalks, and cross-street connections for bicycles/pedestrians. Construction began in early 2022 and the project is expected to partially open to traffic in the first quarter of 2026.
